Debris/Ice /TPS Assessment and Integrated Photographic Analysis for Shuttle Mission STS-56

May 1993

DEBRIS/ICE/TPS ASSESSMENT
AND
PHOTOGRAPHIC ANALYSIS
OF
SHUTTLE MISSION STS-56

April 8, 1993

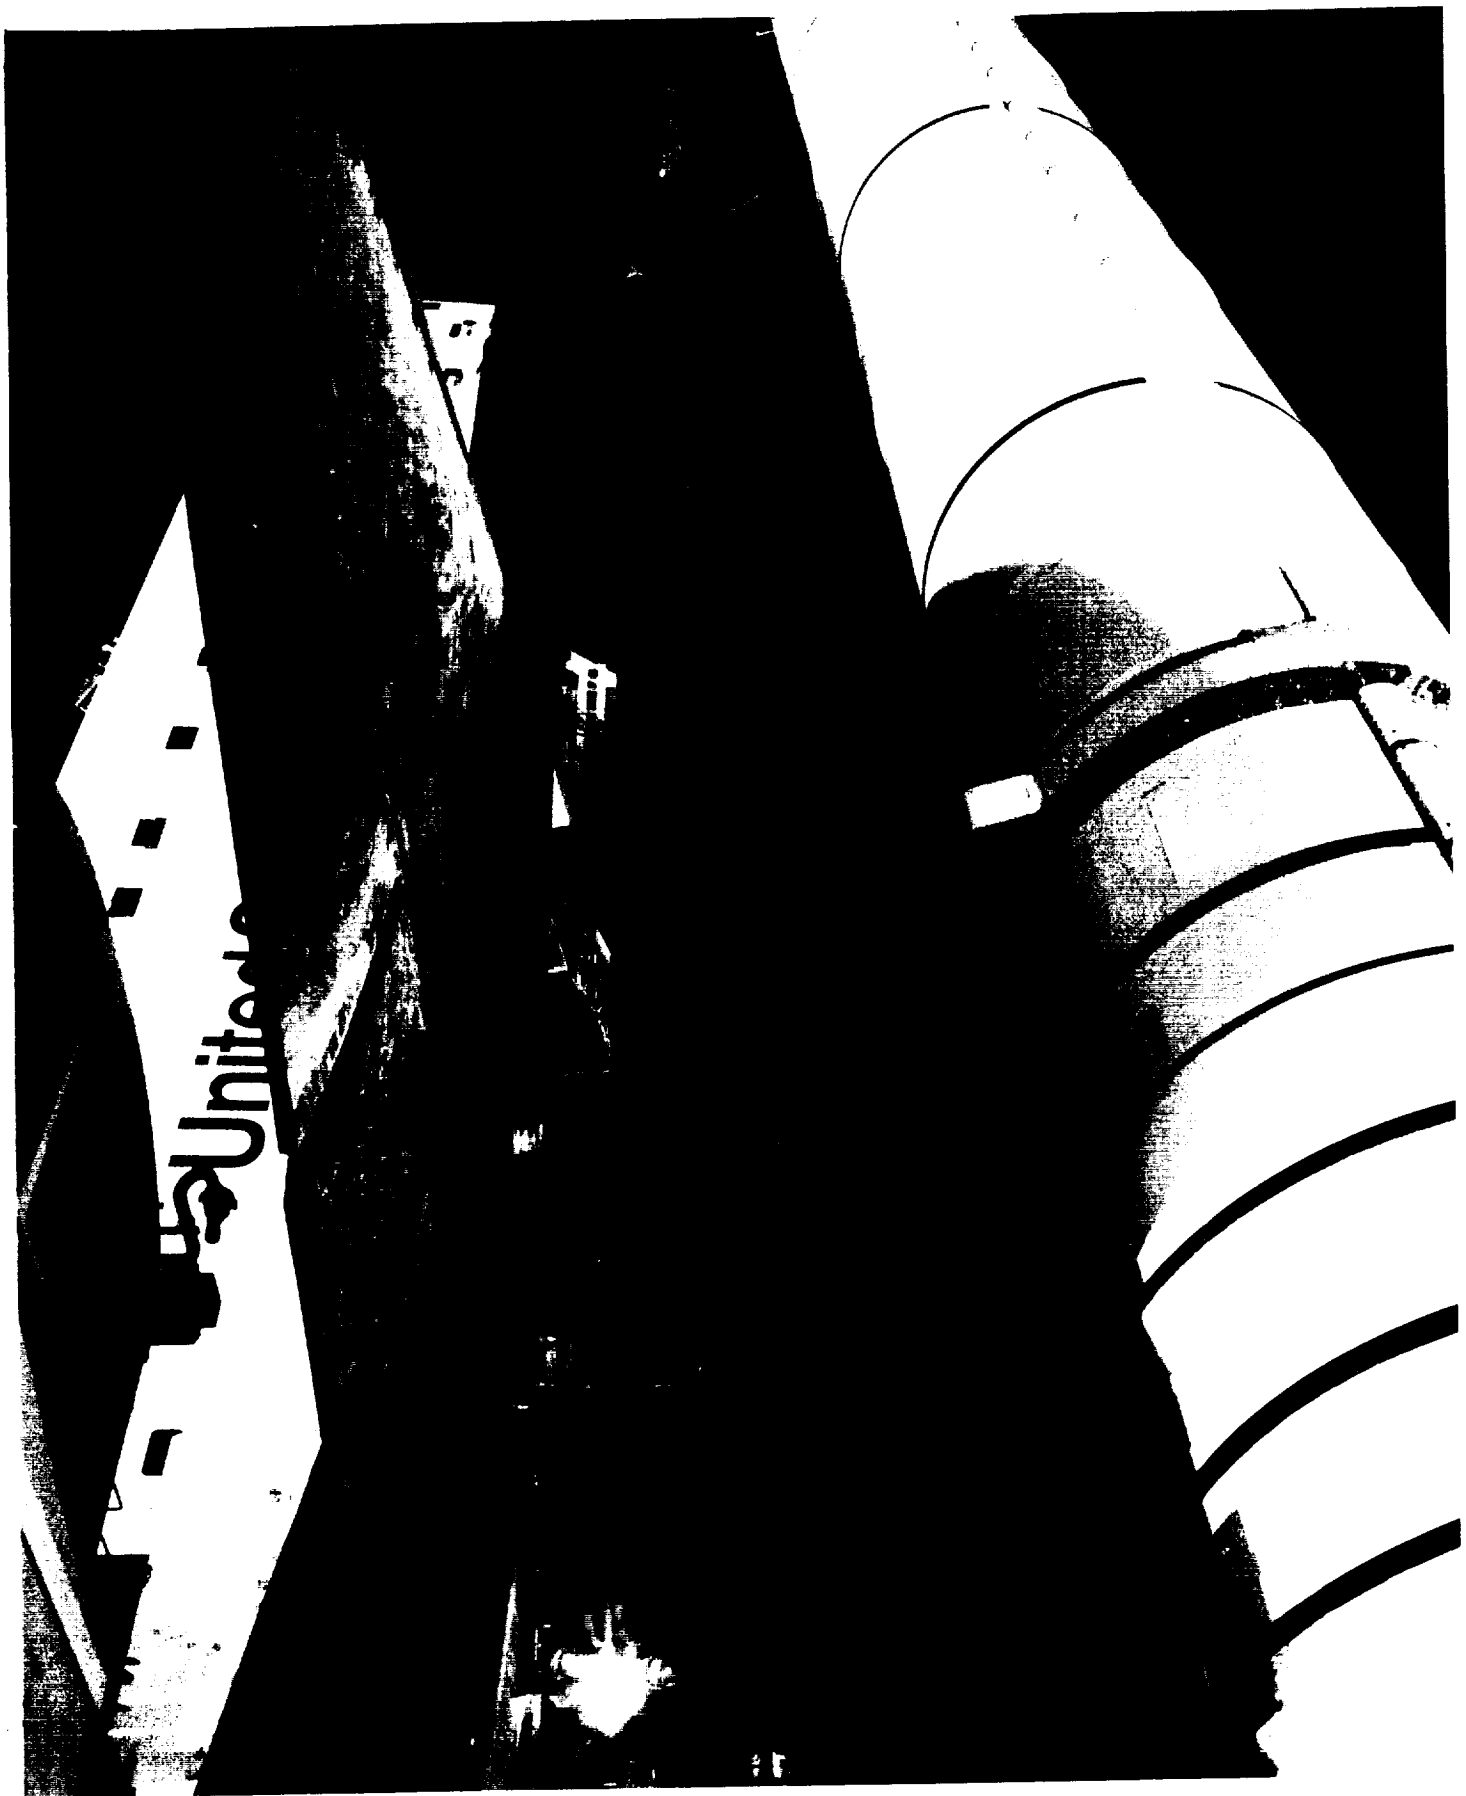
Light condensate, but no ice or frost, was present on the LO₂ and LH₂ tanks. There were no acreage TPS anomalies.

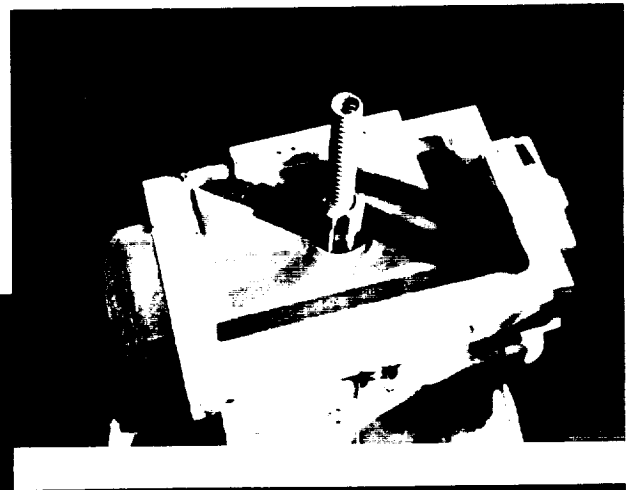
The HDP #5 DCS failure scenario suggests the frangible nut halves rebounded off the lead liner, symmetrically contacted the plunger assembly, and caused localized deformation to the plunger, which in turn allowed the plunger to pass through the stud hole. Once clear of the aft skirt/DCS housing, the plunger and spring became debris that could have been deflected by SRB plume impingement resulting in a potential threat to the vehicle. In this case, the frangible link connecting the plunger to the stud survived the launch environment.

A plunger, spring, and associated hardware from the Debris Containment System (DCS) was found on holddown post #5 still attached to the stud. This hardware is normally contained in the DCS housing and remains with the SRB aft skirt for flight.

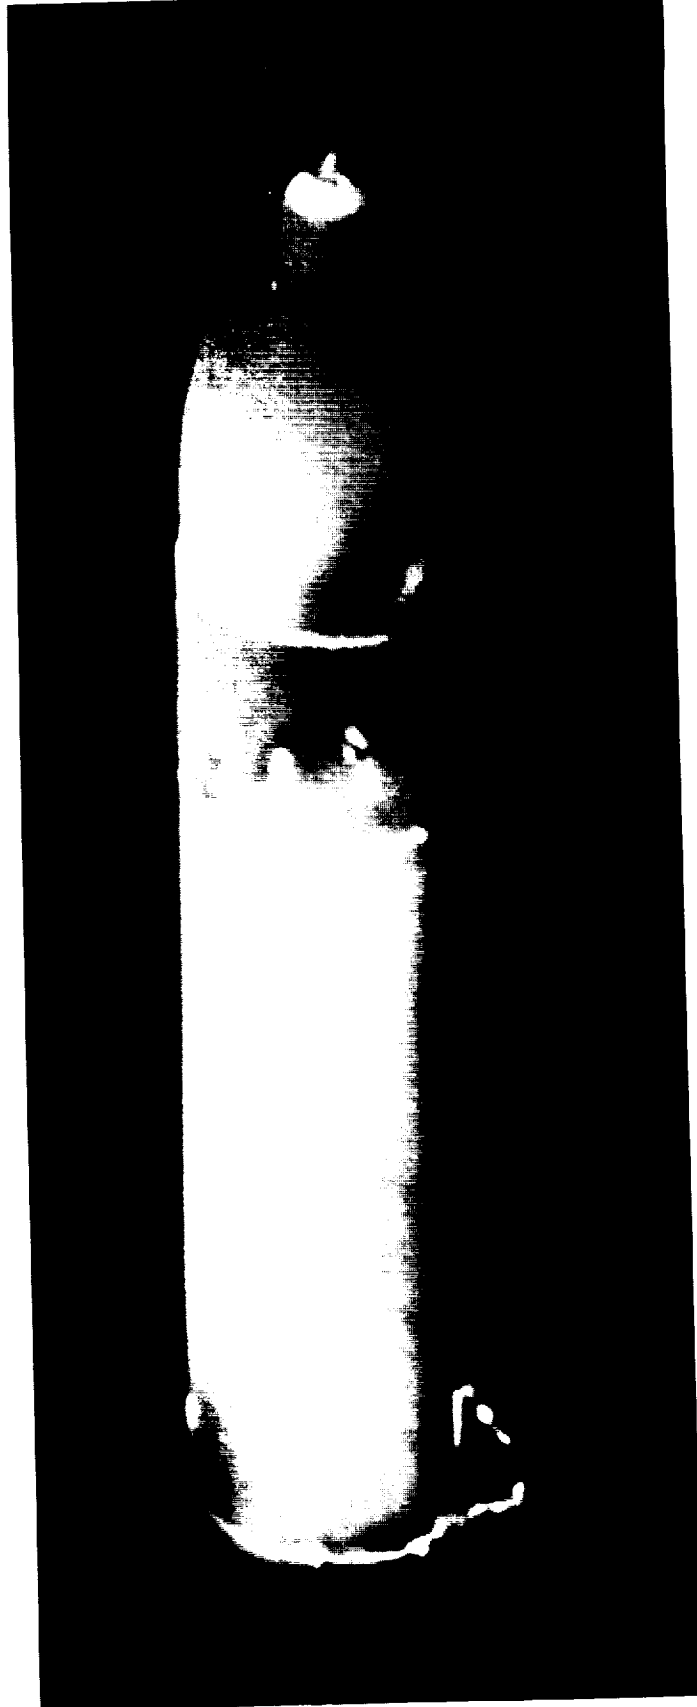
As many as 12 divots were present in the LH2 tank-to-intertank flange closeout on the ET -Z side. Some of the divots were 10-12 inches in diameter.

As many as 11 divots were also visible in the intertank acreage on the -Z side of the ET. Numerous divots appeared in a line and may be indicative of a spray or processing problem. Depth could not be determined due to the absence of shadows or stringers being visible in the divots. Several of the divots were estimated to be 24 inches in diameter. An IFA was taken against the new block of intertanks, which have shown an increasing trend in the appearance of acreage divots.

Eleven divots were visible in the intertank acreage on the ET -Z side. Numerous divots appeared in a line and may be indicative of a spray or processing problem. Depth could not be determined, but several of the divots were estimated to be 24 inches in diameter. Twelve divots, some of which were 10-12 inches in diameter, occurred in the -Z LH2 tank-to-intertank flange closeout.

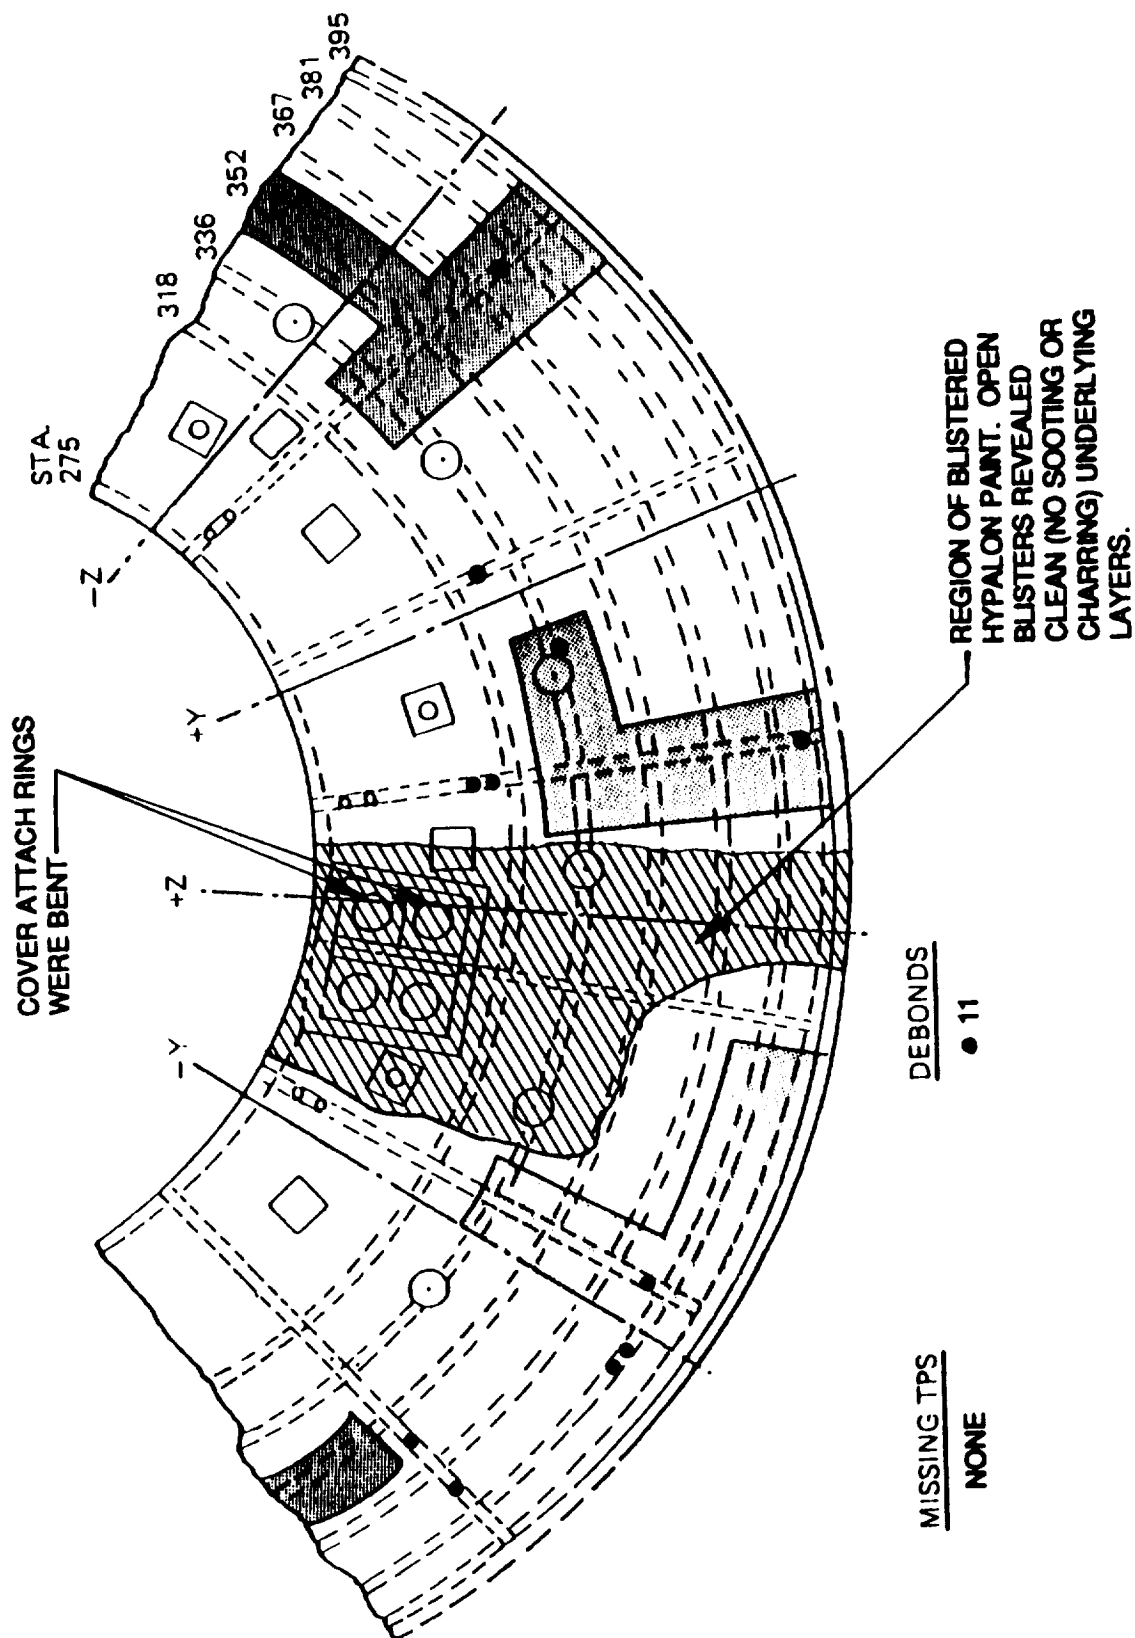
FIGURE 7. RIGHT SRB FRUSTUM

The RH frustum was missing no TPS, but had 11 MSA-2 debonds over fasteners (Figure 7). Significant blistering of the Hypalon paint top layer had occurred in an area between the -Y and +Y axes from the BSM's to the 395 ring frame. No sooting or charring was visible in the open paint blisters and on the Hypalon basecoat. All BSM aero heatshield covers were locked in the fully opened position, although the two right cover attach rings had been bent by parachute riser entanglement.

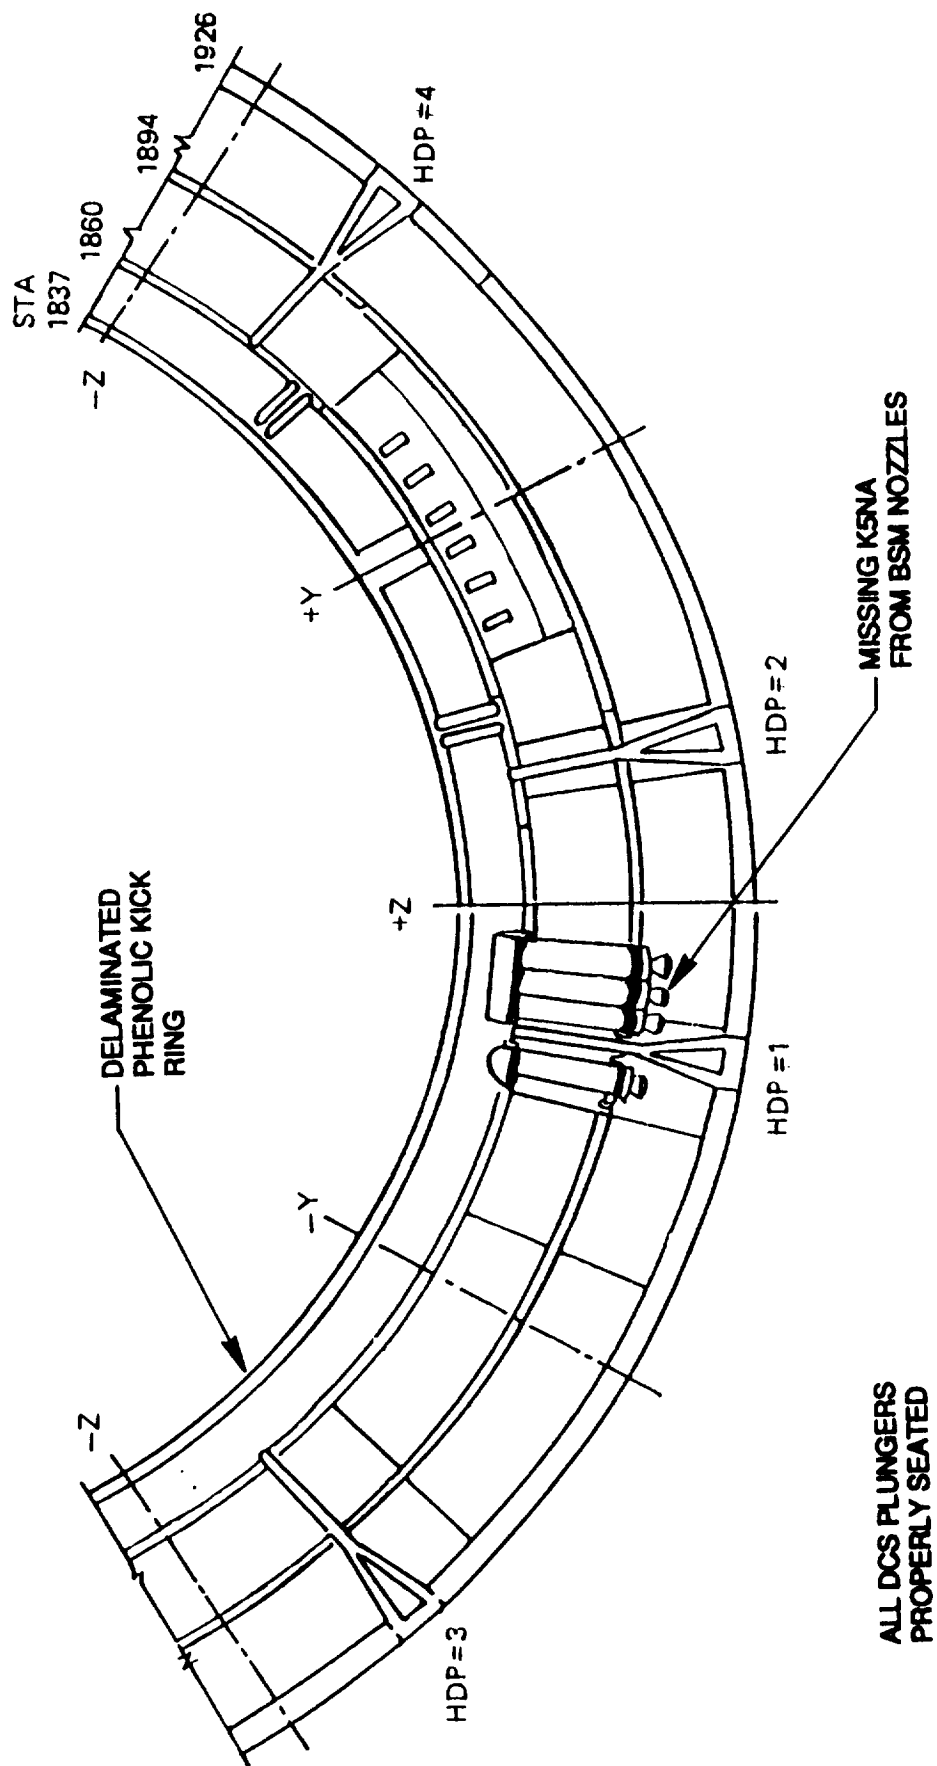
FIGURE 9. RIGHT SRB AFT SKIRT EXTERIOR TPS

The phenolic material on the kick ring was delaminated. The K5NA closeouts (protective domes) on the kick ring forward and aft fasteners are no longer used. RTV-133 has replaced the K5NA over the forward fasteners. The aft skirt acreage TPS was generally in good condition (Figure 9).

None of the aft skirt HDP EPON shim material was lost prior to splashdown. All four Debris Containment System (DCS) plungers were seated properly.

TYPICAL BLISTERING OF
HYPALON PAINT ON ET
ATTACH FITTING AND
SYSTEMS TUNNEL COVER

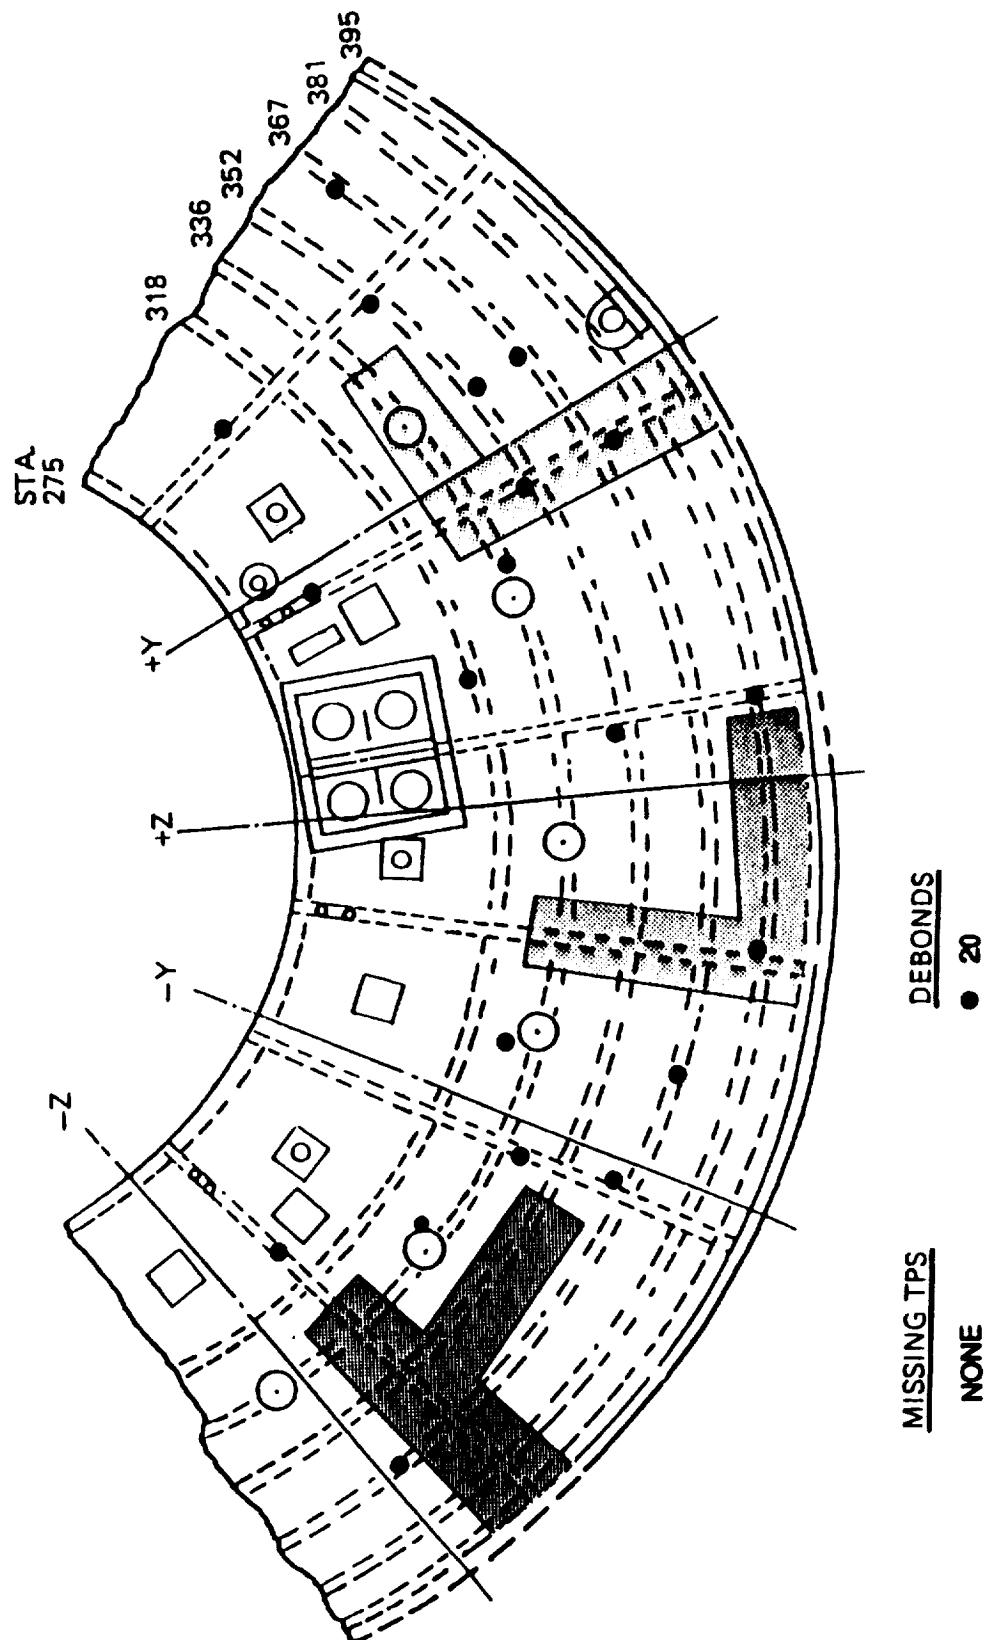
FIGURE 10. LEFT SRB FRUSTUM

The LH frustum was missing no TPS, but had a total of 20 MSA-2 debonds (Figure 10). Minor localized blistering of the Hypalon paint had occurred along the 395 ring. The BSM aero heat shield covers were locked in the fully opened position.

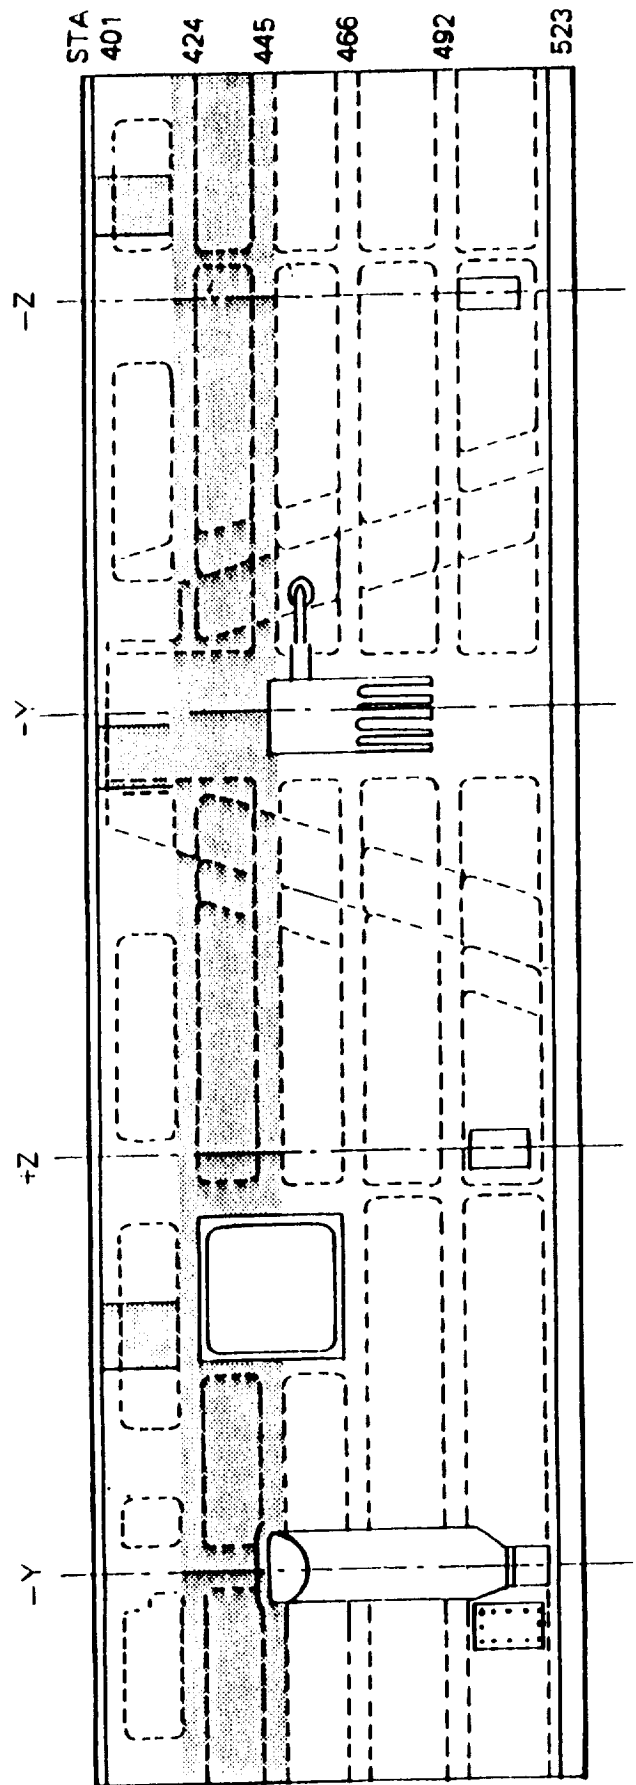
FIGURE 11. LEFT SRB FWD SKIRT

The LH forward skirt exhibited no debonds or missing TPS. Both RSS antennae covers/phenolic base plates were intact. Minor blistering of the Hypalon paint occurred near the ET/SRB attach point and on the systems tunnel cover (Figure 11). No pins were missing from the frustum severance ring. The forward separation bolt appeared to have separated cleanly.

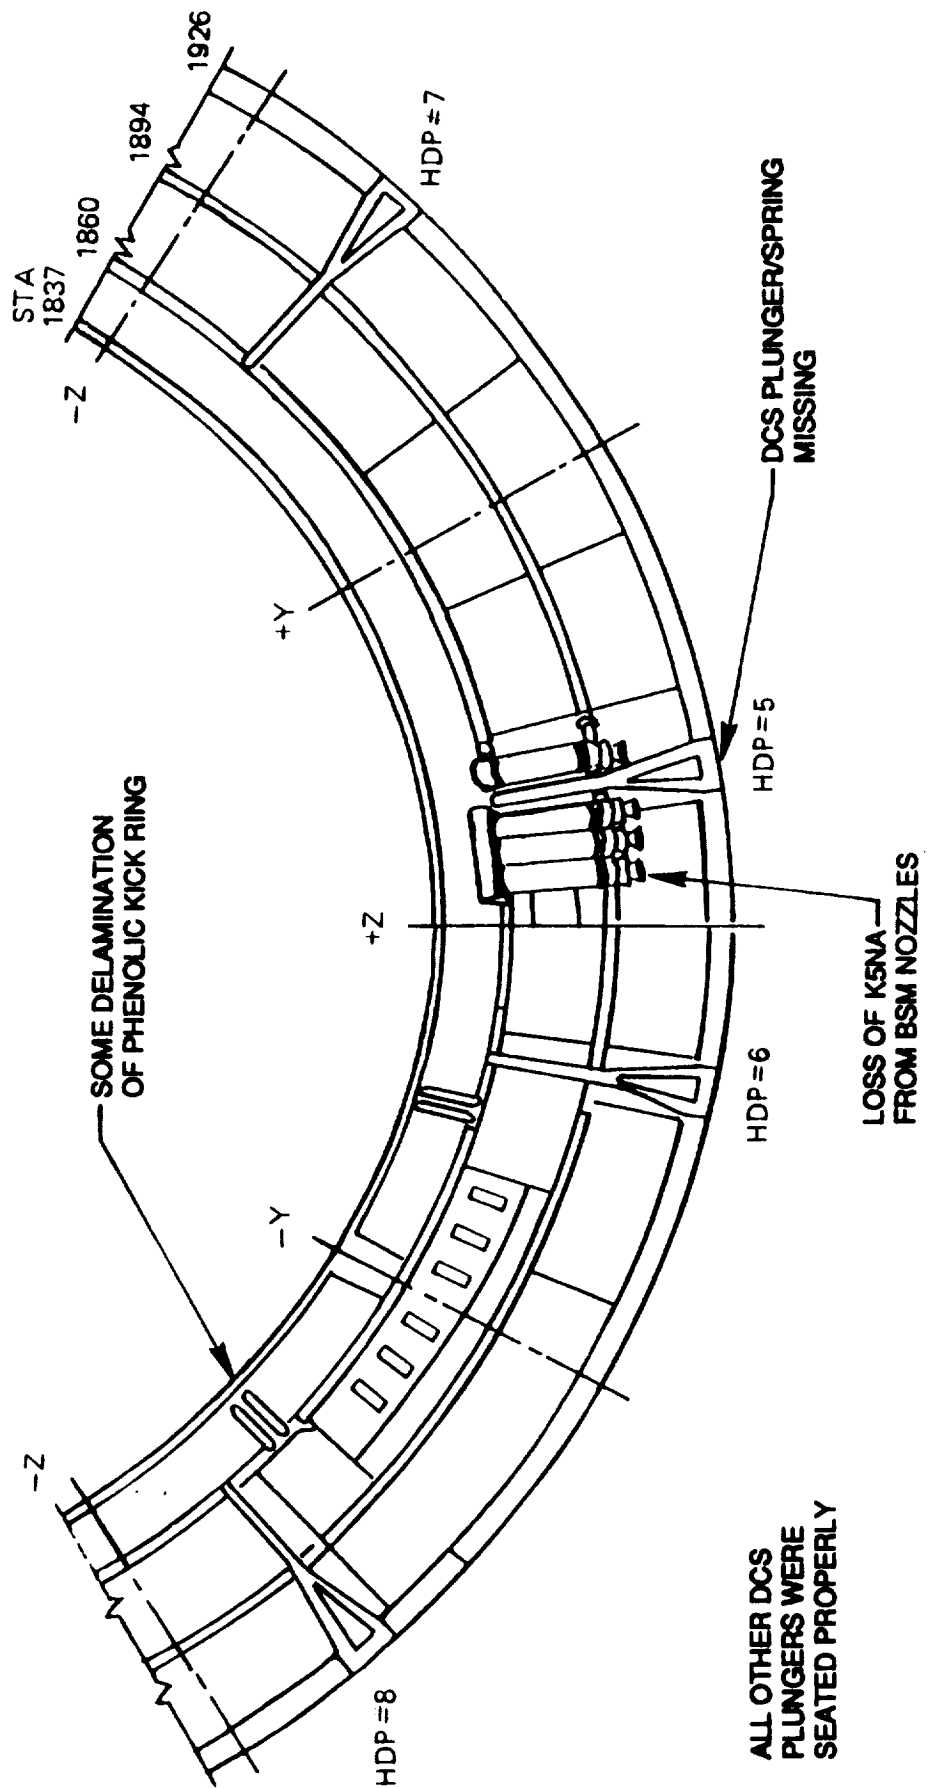
FIGURE 12. LEFT SRB AFT SKIRT EXTERIOR TPS

The phenolic material on the kick ring was delaminated in only localized areas. The K5NA closeouts (protective domes) on the kick ring forward and aft fasteners are no longer used. RTV-133 has replaced the K5NA over the forward fasteners. The aft skirt acreage TPS was generally in good condition (Figure 12).

Examination of the Holddown Post #5 stud hole revealed no obvious broaching or unusual abrasion due to the loss of the Debris Containment System (DCS) plunger/spring. The frangible nut halves were contained inside the DCS housing. The amount of debris lost from the DCS will be determined during the post flight disassembly. The other three DCS plungers were seated properly. None of the aft skirt HDP EPON shim material was lost prior to splashdown.

TPS MISSING
NONE

DEBONDS
NONE

LOCALIZED BLISTERING OF
HYPALON PAINT AROUND
ET/SRB ATTACH FITTING AND
SYSTEMS TUNNEL COVER

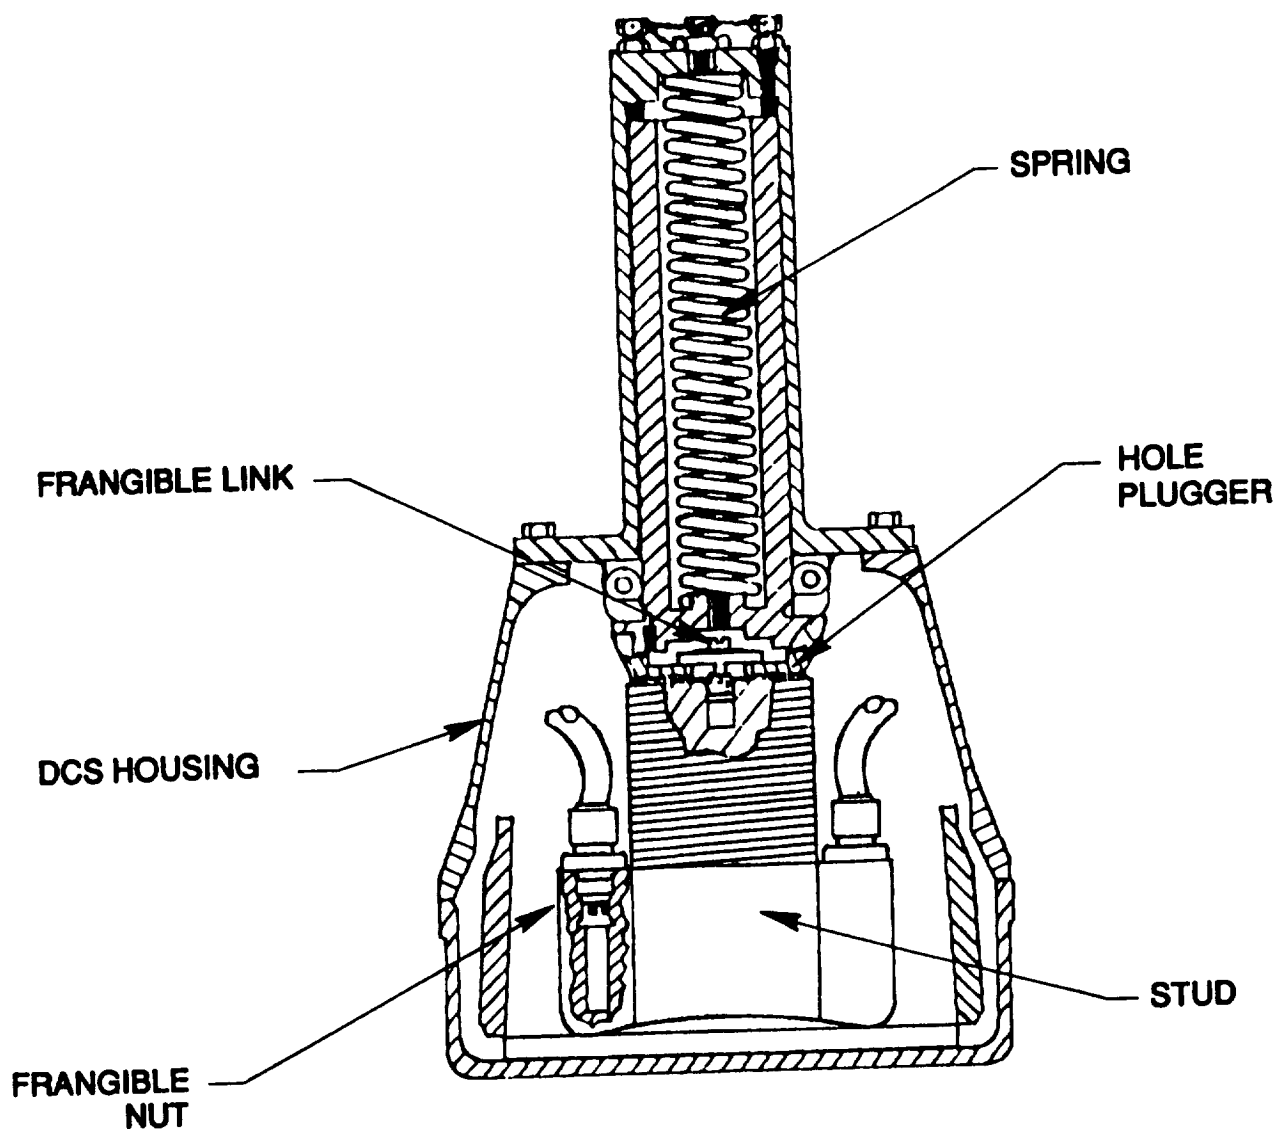
Figure 13. DEBRIS CONTAINMENT SYSTEM (DCS)

The current failure scenario suggests the frangible nut halves rebounded off the lead liner, symmetrically contacted the plunger assembly, and caused localized deformation to the plunger, which in turn allowed the plunger to pass through the stud hole (ref Figure 13). Once clear of the aft skirt/DCS housing, the plunger and spring became debris that could have been deflected by SRB plume impingement resulting in a potential threat to the vehicle. In this case, the frangible link connecting the plunger to the stud survived the launch environment.

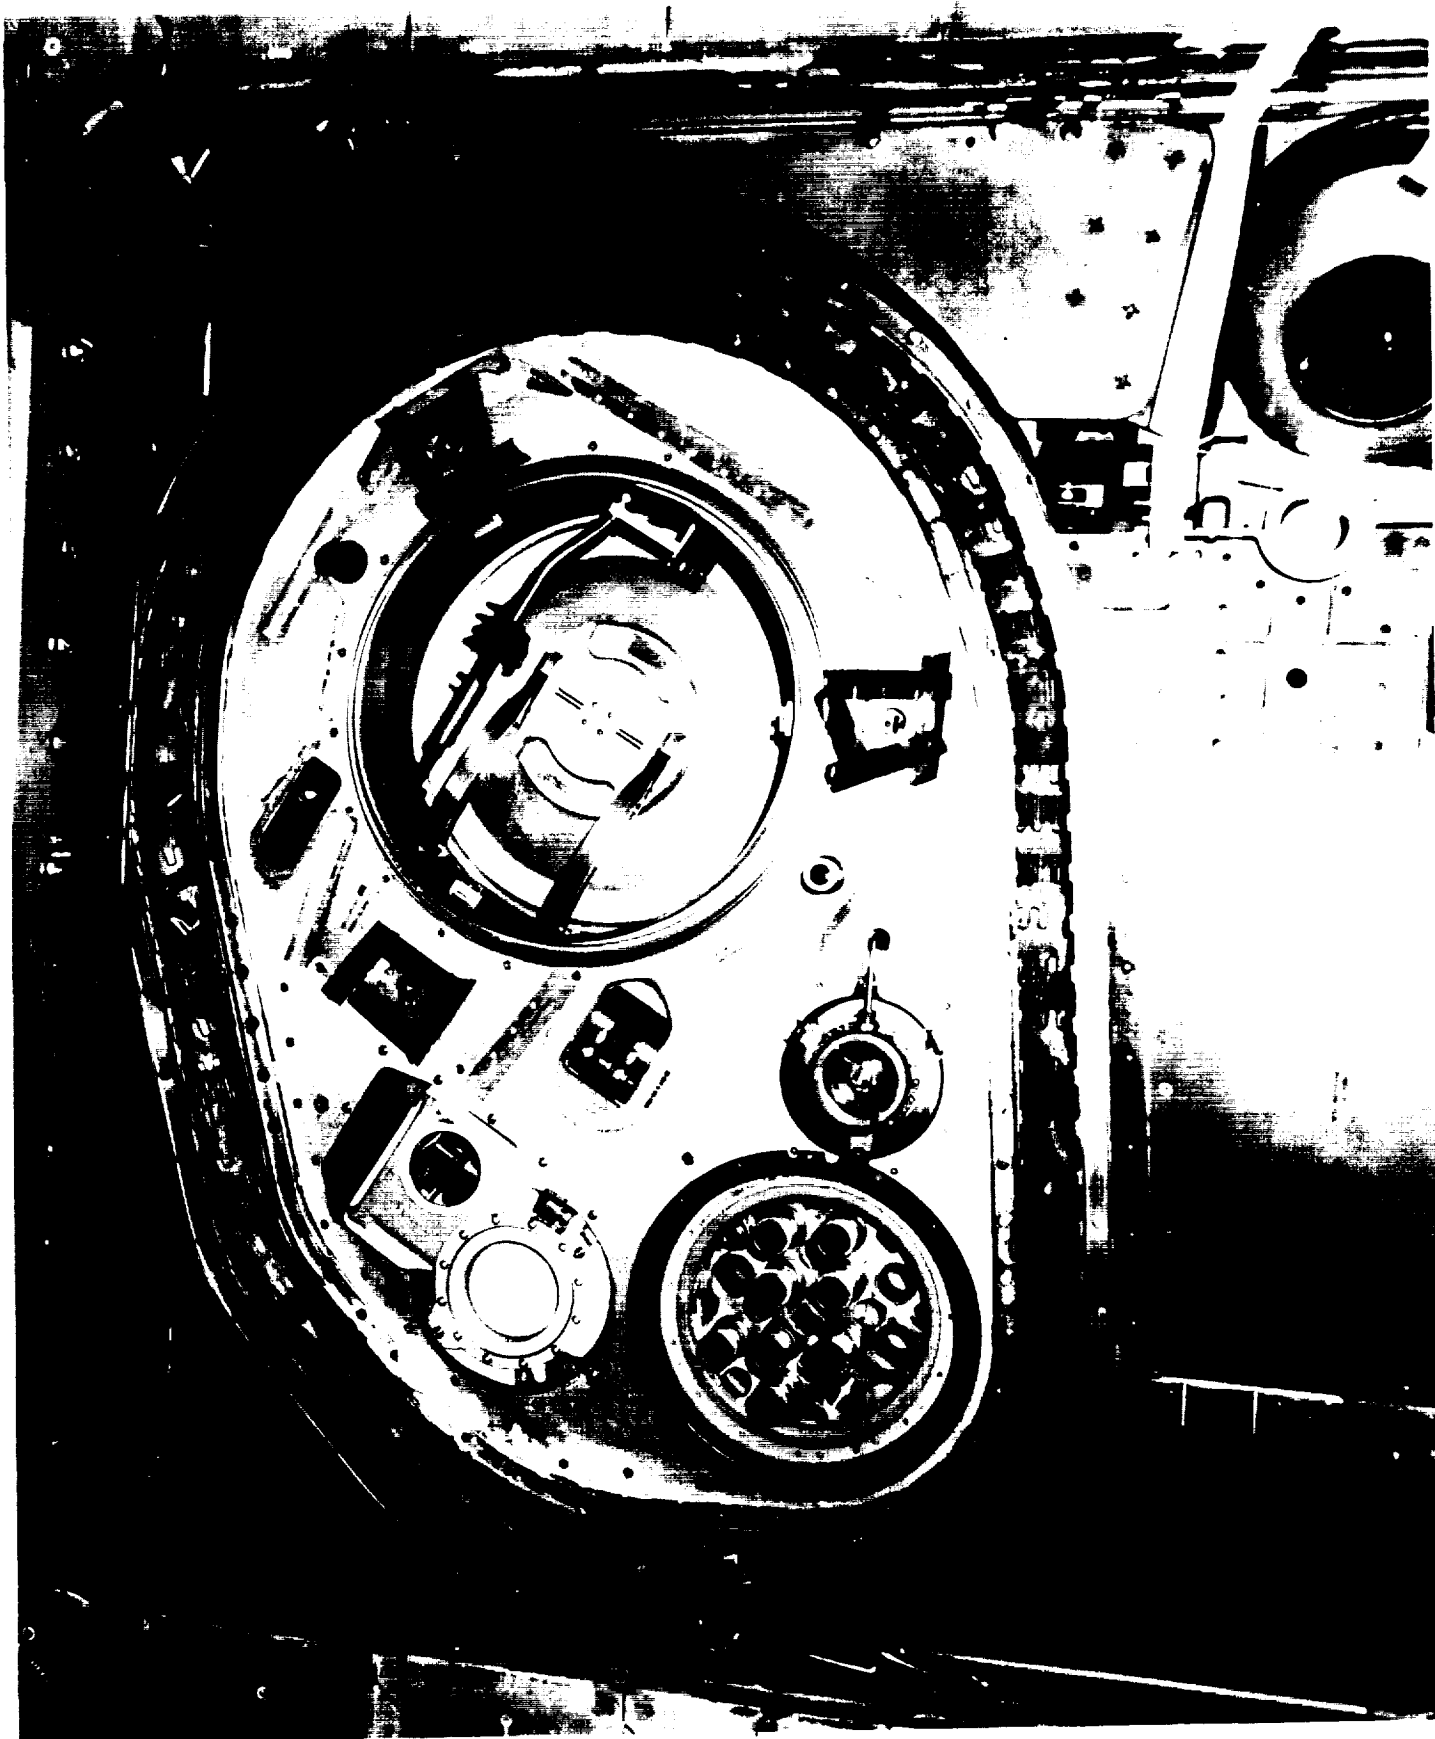
Overall view of the LH2 ET/ORB umbilical. All separation ordnance devices functioned properly. No flight hardware was found on the runway below the umbilical when the ET door was opened.

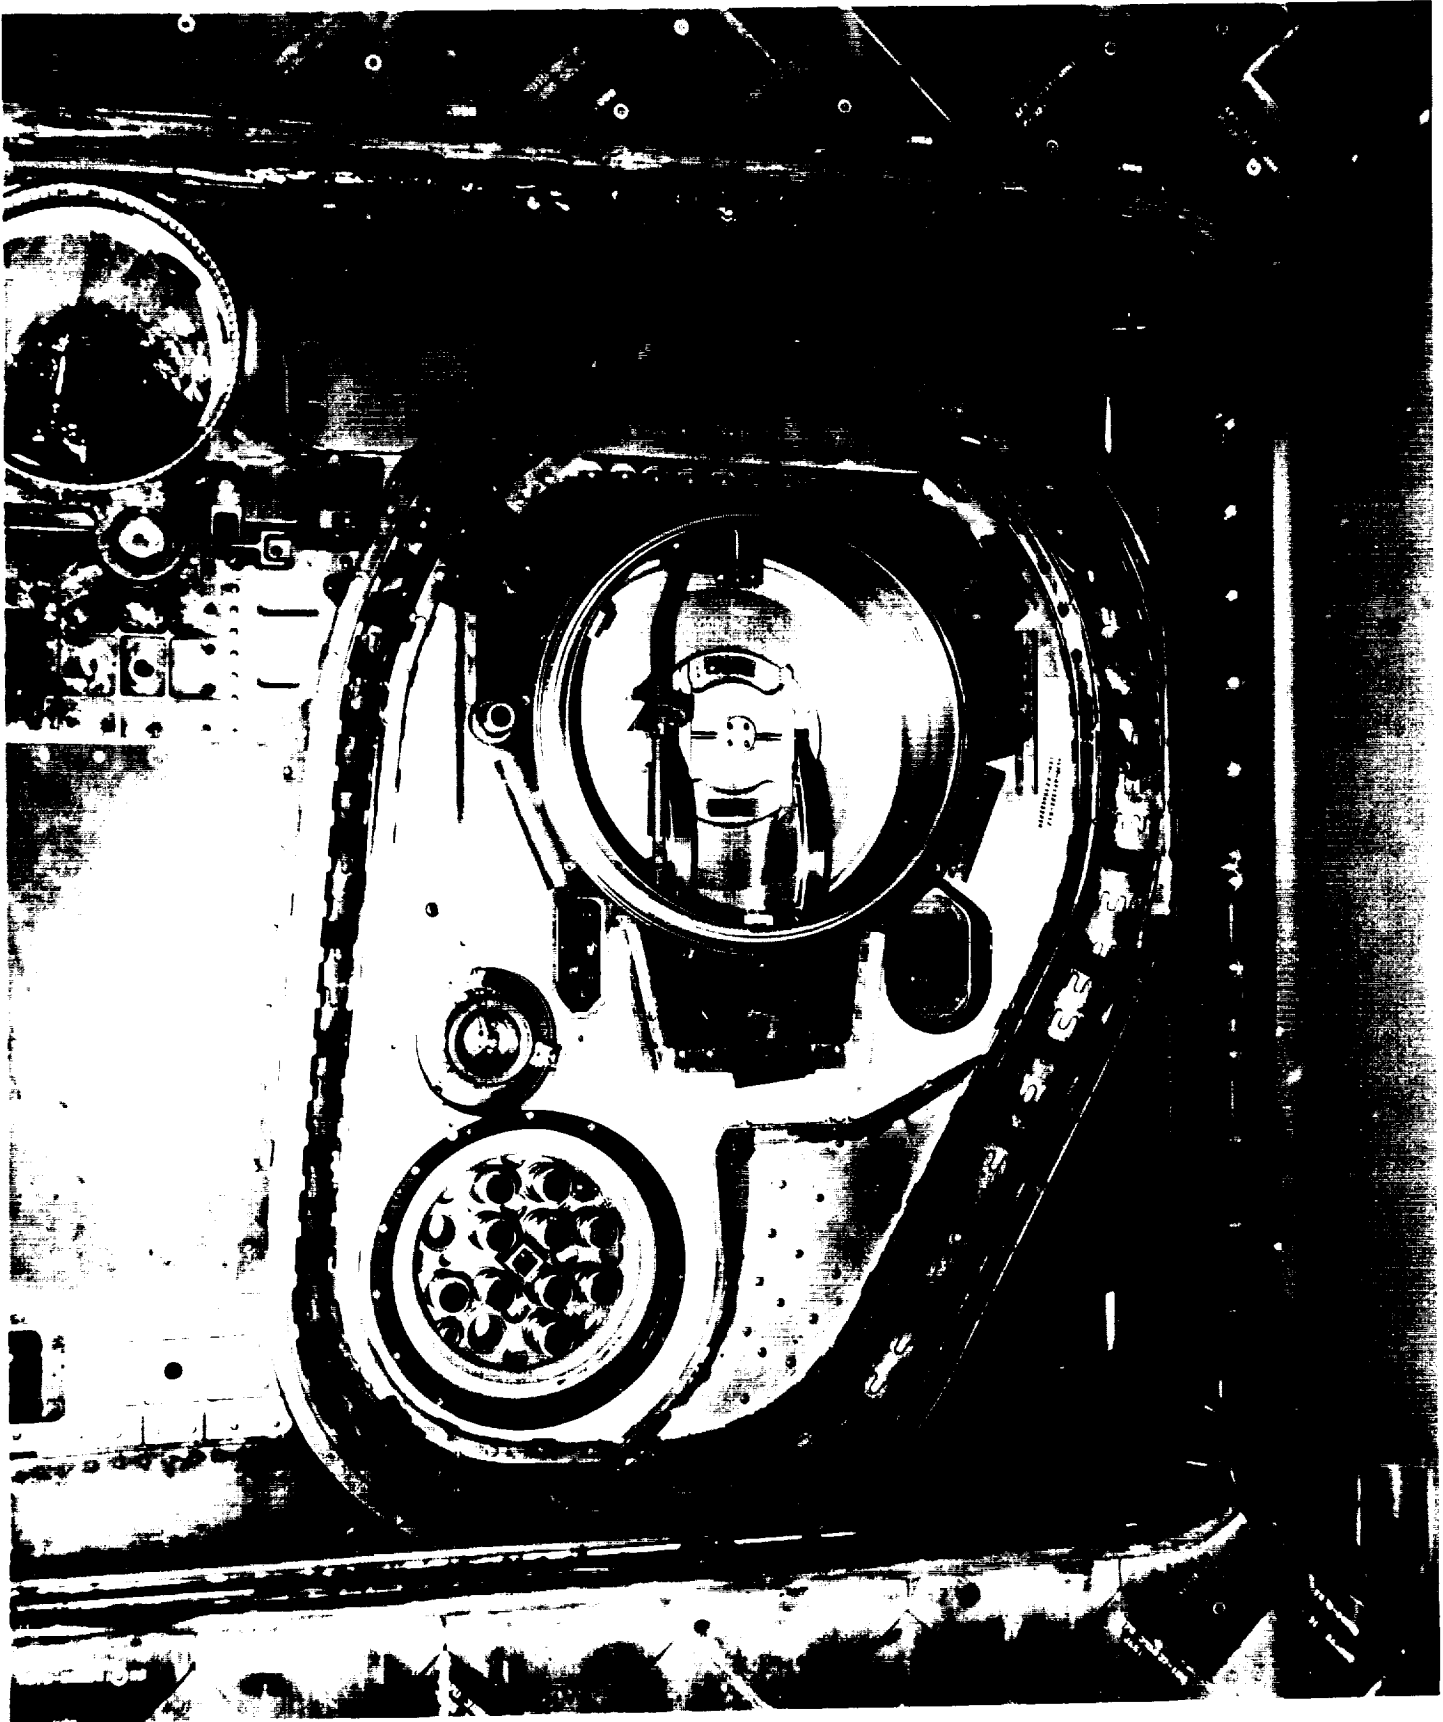
Overall view of the L02 ET/ORB umbilical. All separation ordnance devices functioned properly. No flight hardware was found on the runway below the umbilical when the ET door was opened.

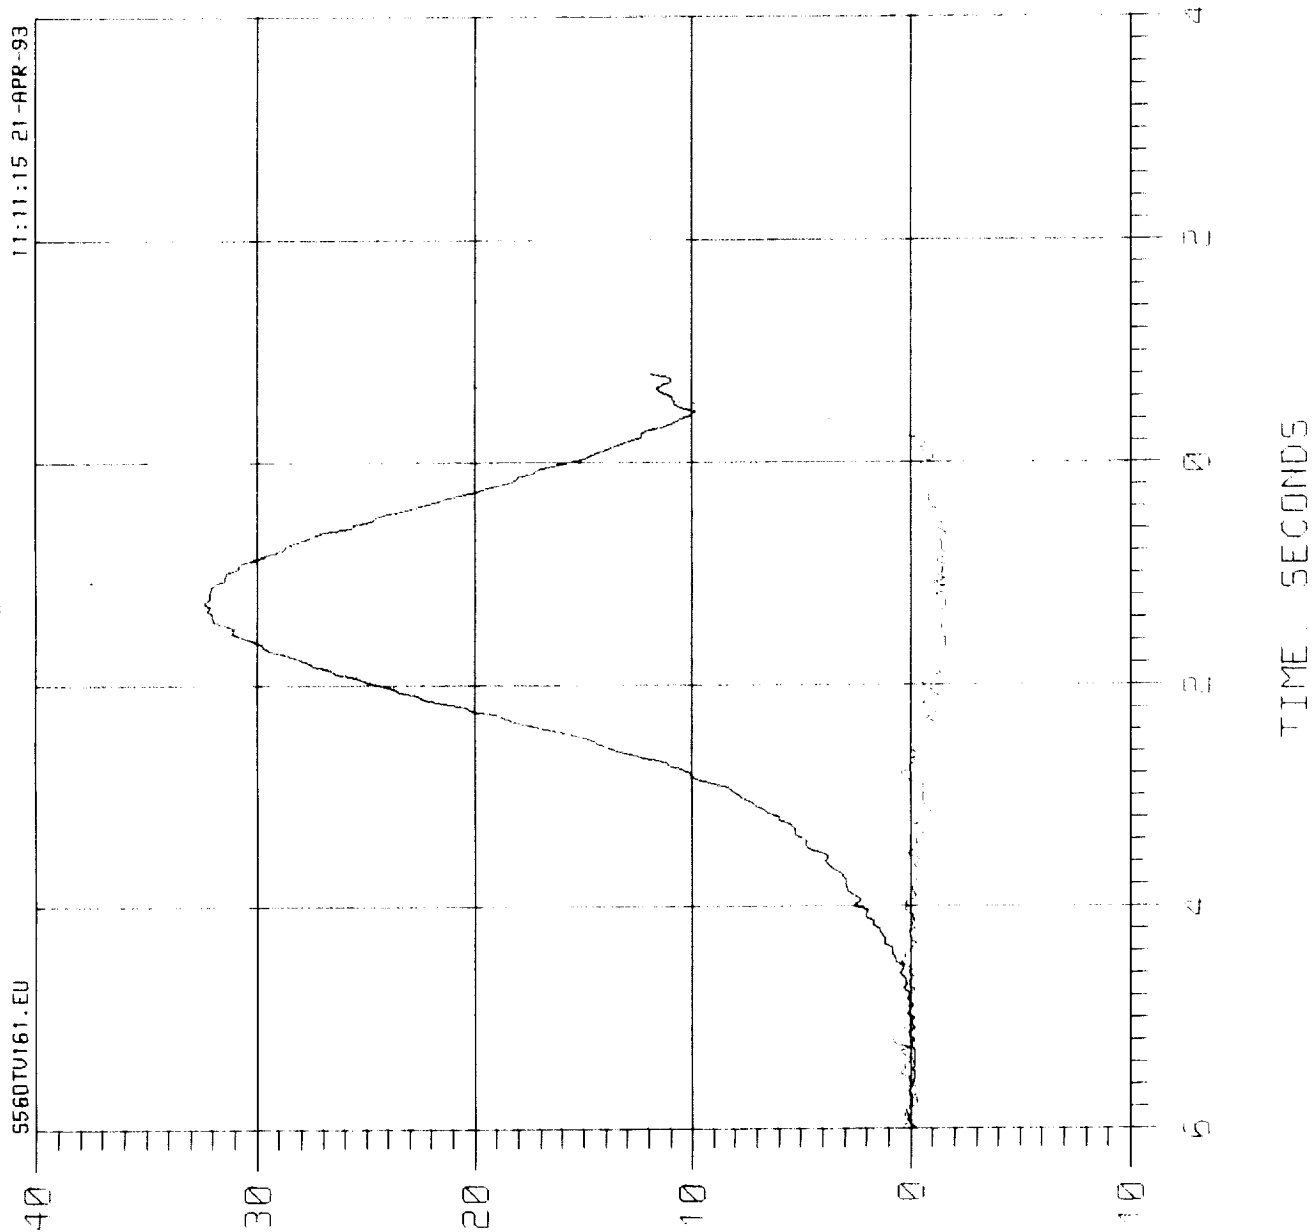
Maximum ET tip deflection for this mission was determined to be approximately 32.4 inches. Figure 18 is a data plot showing the measured motion of the ET tip in both the horizontal and vertical directions. These data were derived from camera OTV-161.
